Live/Real Time Three-Dimensional Transesophageal Echocardiographic Evaluation of Mitral and Aortic Valve Prosthetic Paravalvular Regurgitation

(*Cardiovasc. j.* 2010; 2(2) : 121-127)

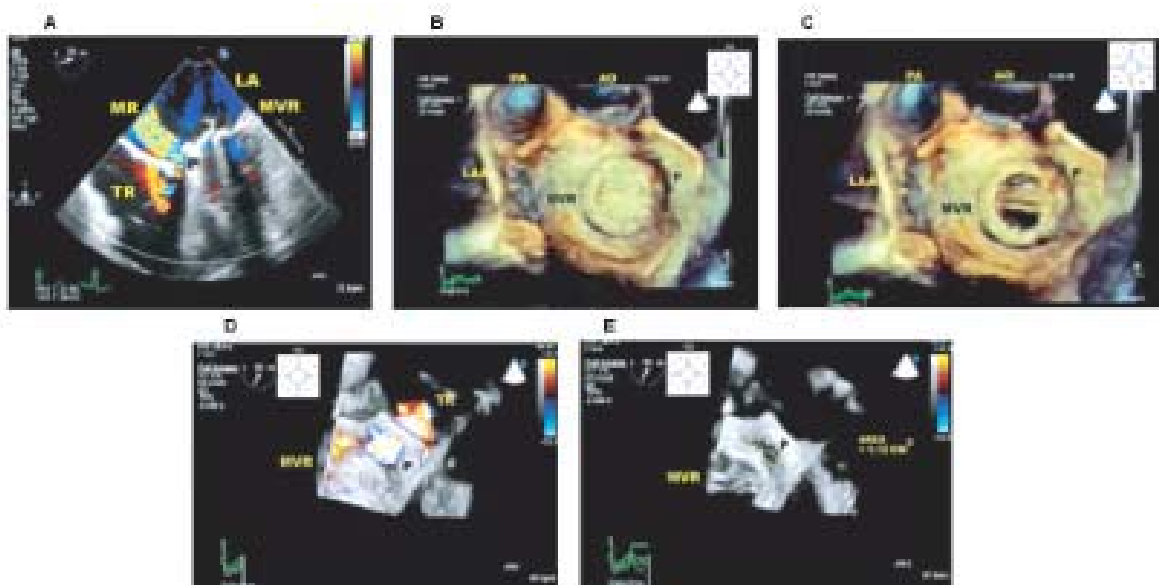
Fig-1: Paravalvular mitral prosthetic regurgitation (Case 1). A. Two-dimensional transesophageal echocardiogram shows medial paravalvular (P) mitral regurgitation (MR) in this patient with St Jude mitral valve replacement (MVR). B–E. Live/real time three-dimensional transesophageal echocardiogram. En face views. The paravalvular (P) defect is localized at the 1–3 o'clock position in both systole (B) and diastole (C). Color Doppler examination (D) confirms the site of the paravalvular (P) defect. The paravalvular (P) defect after color Doppler suppression is shown in E. The defect measured 1.12 cm². AO = aorta; LA = left atrium; LAA = left atrial appendage; PA = pulmonary artery; TR = tricuspid regurgitation.

In all of the patients, 3D TEE was able to provide more information regarding the location and size of the paravalvular defect as compared to 2D TEE (Table I, Figs. 1–6). In the first patient, 3D TEE showed a defect at the 12–2 o’clock position, with dimensions of 1.3 × 1.2 cm which correlated well with the surgeon’s finding of a 1.5 × 1.0 cm defect at the anterior annulus. In all of the other patients, 3D TEE again provided very good localization of the defect based on the surgeon’s clock view or other landmarks. In addition to correlating well with the surgical findings, 3D TEE also provided an estimate of the size of the defect. In one patient with a mitral prosthetic leak, fewer sutures were visualized in the region of annulus. Also, in two patients, both with mitral prosthesis, increased motion (“rocking”) of the ring during the cardiac

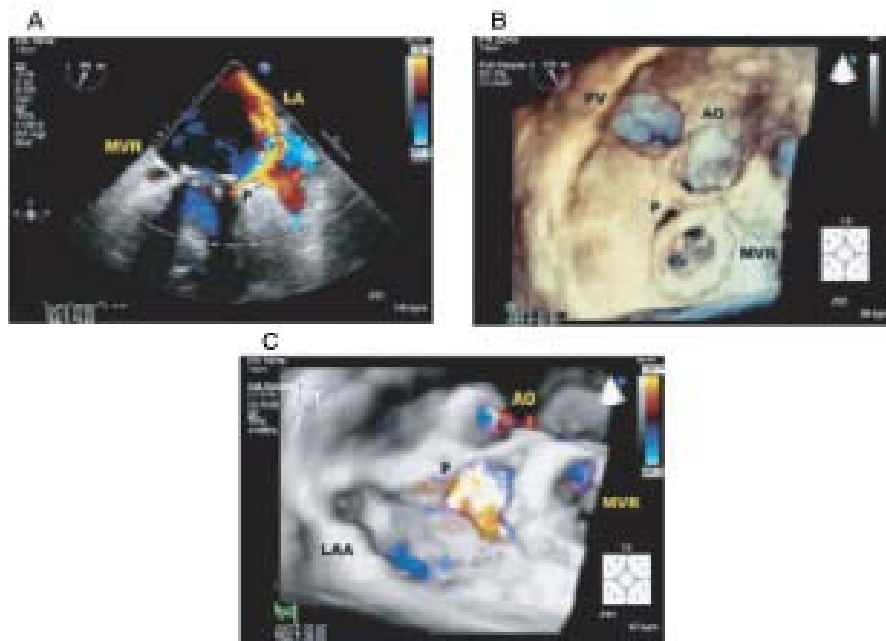
Fig.-2: Paravalvular mitral prosthetic regurgitation (Case 9). A. Two-dimensional transesophageal echocardiogram shows lateral paravalvular (P) MR in this patient with porcine MVR. B, C. Live/real time three-dimensional transesophageal echocardiogram. En face views. The paravalvular (P) defect is localized at the 10–11 o’clock position (B). Color Doppler examination (C) confirms the site of the defect. PV = pulmonary valve. Other abbreviations as in the previous figure.

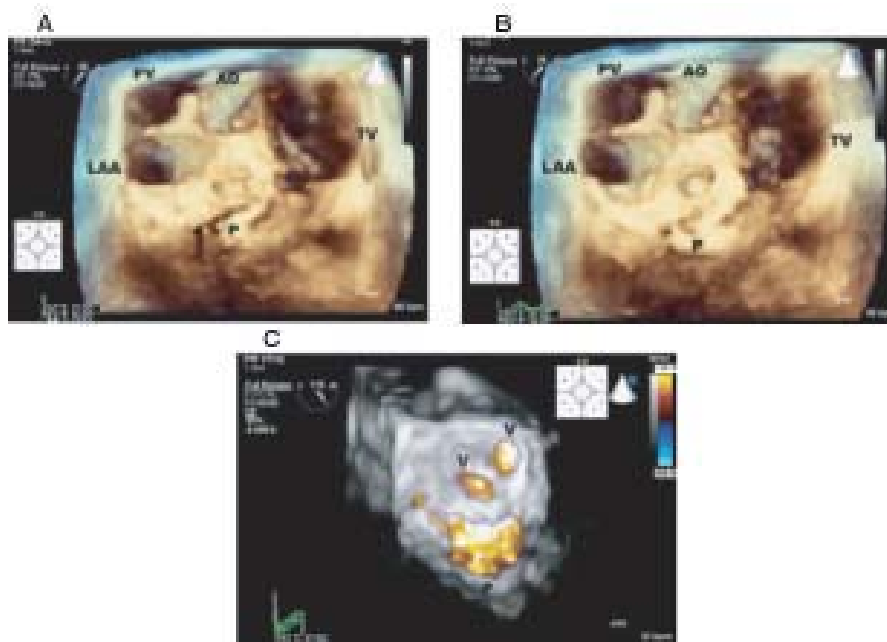
Fig.-3: Paravalvular mitral prosthetic regurgitation (Case 8). A–C. Live/real time three-dimensional transesophageal echocardiogram. En face views. The paravalvular (P) defect is localized at the 5–8 o’clock position in both systole (A) and diastole (B) in this patient with Starr Edwards MVR. Color Doppler examination (C) confirms the site of paravalvular (P) defect. TV = tricuspid valve; V = valvular regurgitation. Other abbreviations as in previous figures.

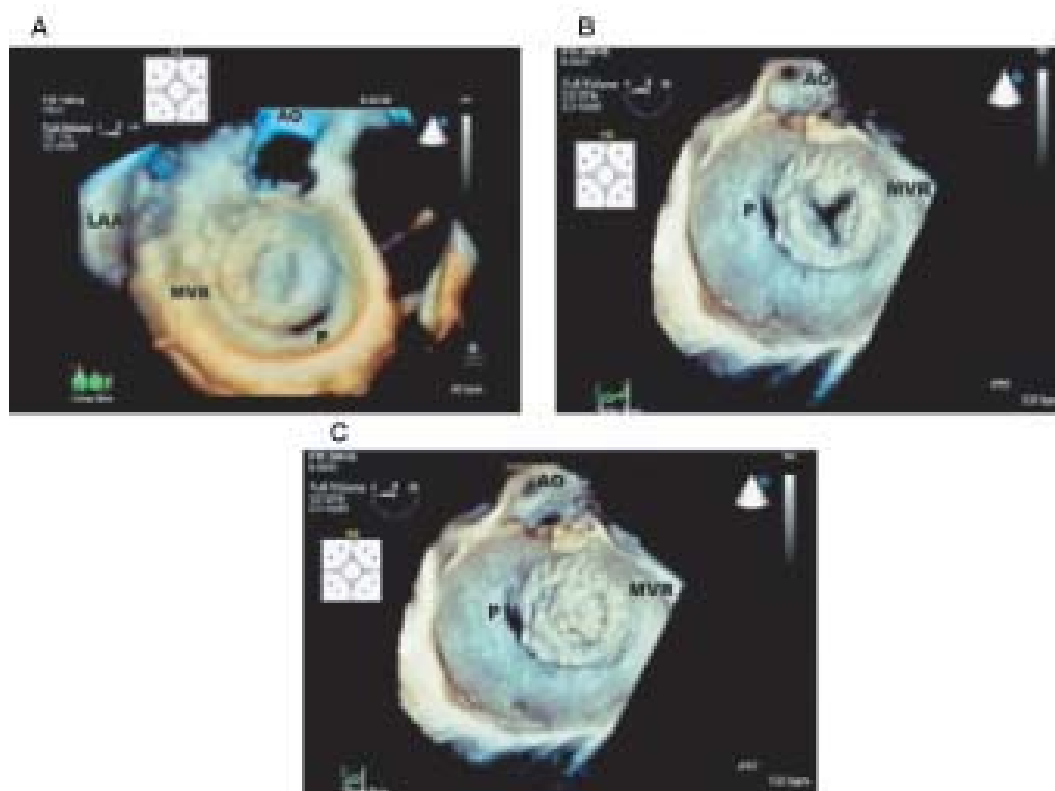
Fig.-4: Paravalvular mitral prosthetic regurgitation. Live/real time three-dimensional transesophageal echocardiogram. En face views. A (Case 2). The paravalvular (P) defect is localized at the 5 o'clock position in this patient with a metallic prosthesis. B, C (Case 10). Another patient with a tissue prosthesis shows paravalvular (P) defect at the 8–9 o'clock position in both systole and diastole. Abbreviations as in previous figures.

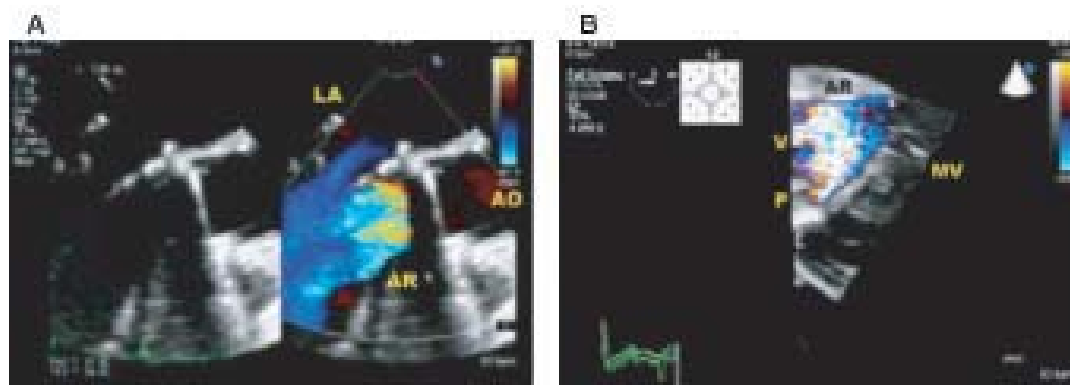
Figure 5. Paravalvular aortic prosthetic regurgitation (Case 12). A. Two-dimensional transesophageal echocardiogram. In this patient with a metallic prosthesis, color Doppler signals fill the whole extent of proximal left ventricular outflow tract in diastole consistent with severe aortic regurgitation (AR). It is difficult to assess the site of AR but it appears primarily valvular, not paravalvular. B. Live/real time three-dimensional transesophageal echocardiogram. Paravalvular (P) regurgitation is located at the 7 o'clock position. Two jets of valvular (V) regurgitation are also visualized within the confines of the prosthesis. MV = mitral valve. Other abbreviations as in previous figures.

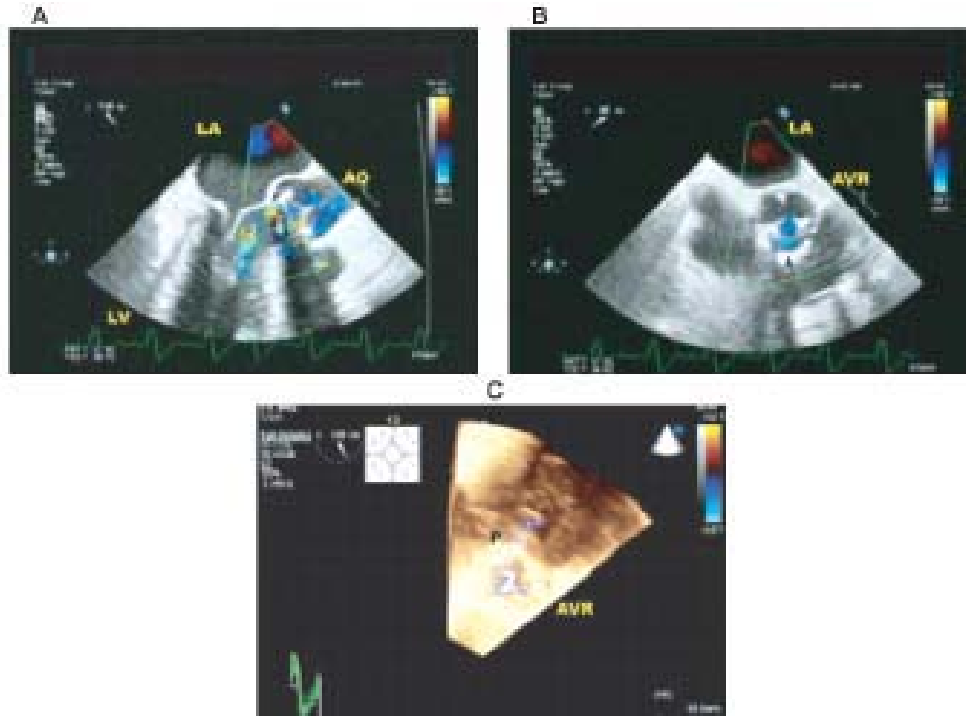
Fig.-6: Paravalvular aortic prosthetic regurgitation (Case 13). A, B. Two-dimensional transesophageal echocardiogram. Both posterior (A) and anterior (B) paravalvular (P) regurgitation jets (arrow head) are seen in five-chamber and short-axis views, respectively, in this patient with a tissue aortic valve replacement (AVR). C. Live/real time threedimensional transesophageal echocardiogram. A large paravalvular (P) defect is seen anteriorly at the 1 o'clock position. LV = left ventricle. Other abbreviations as in previous figures.
